## MEMORANDUM

**To:** Jason Gunter, U.S. Environmental Protection Agency  
**From:** Marcia Greenblatt  
**Date:** February 2014  
**Subject:** Big River OU-2 Visual Railroad Bed Survey  
**Project No.:** C816

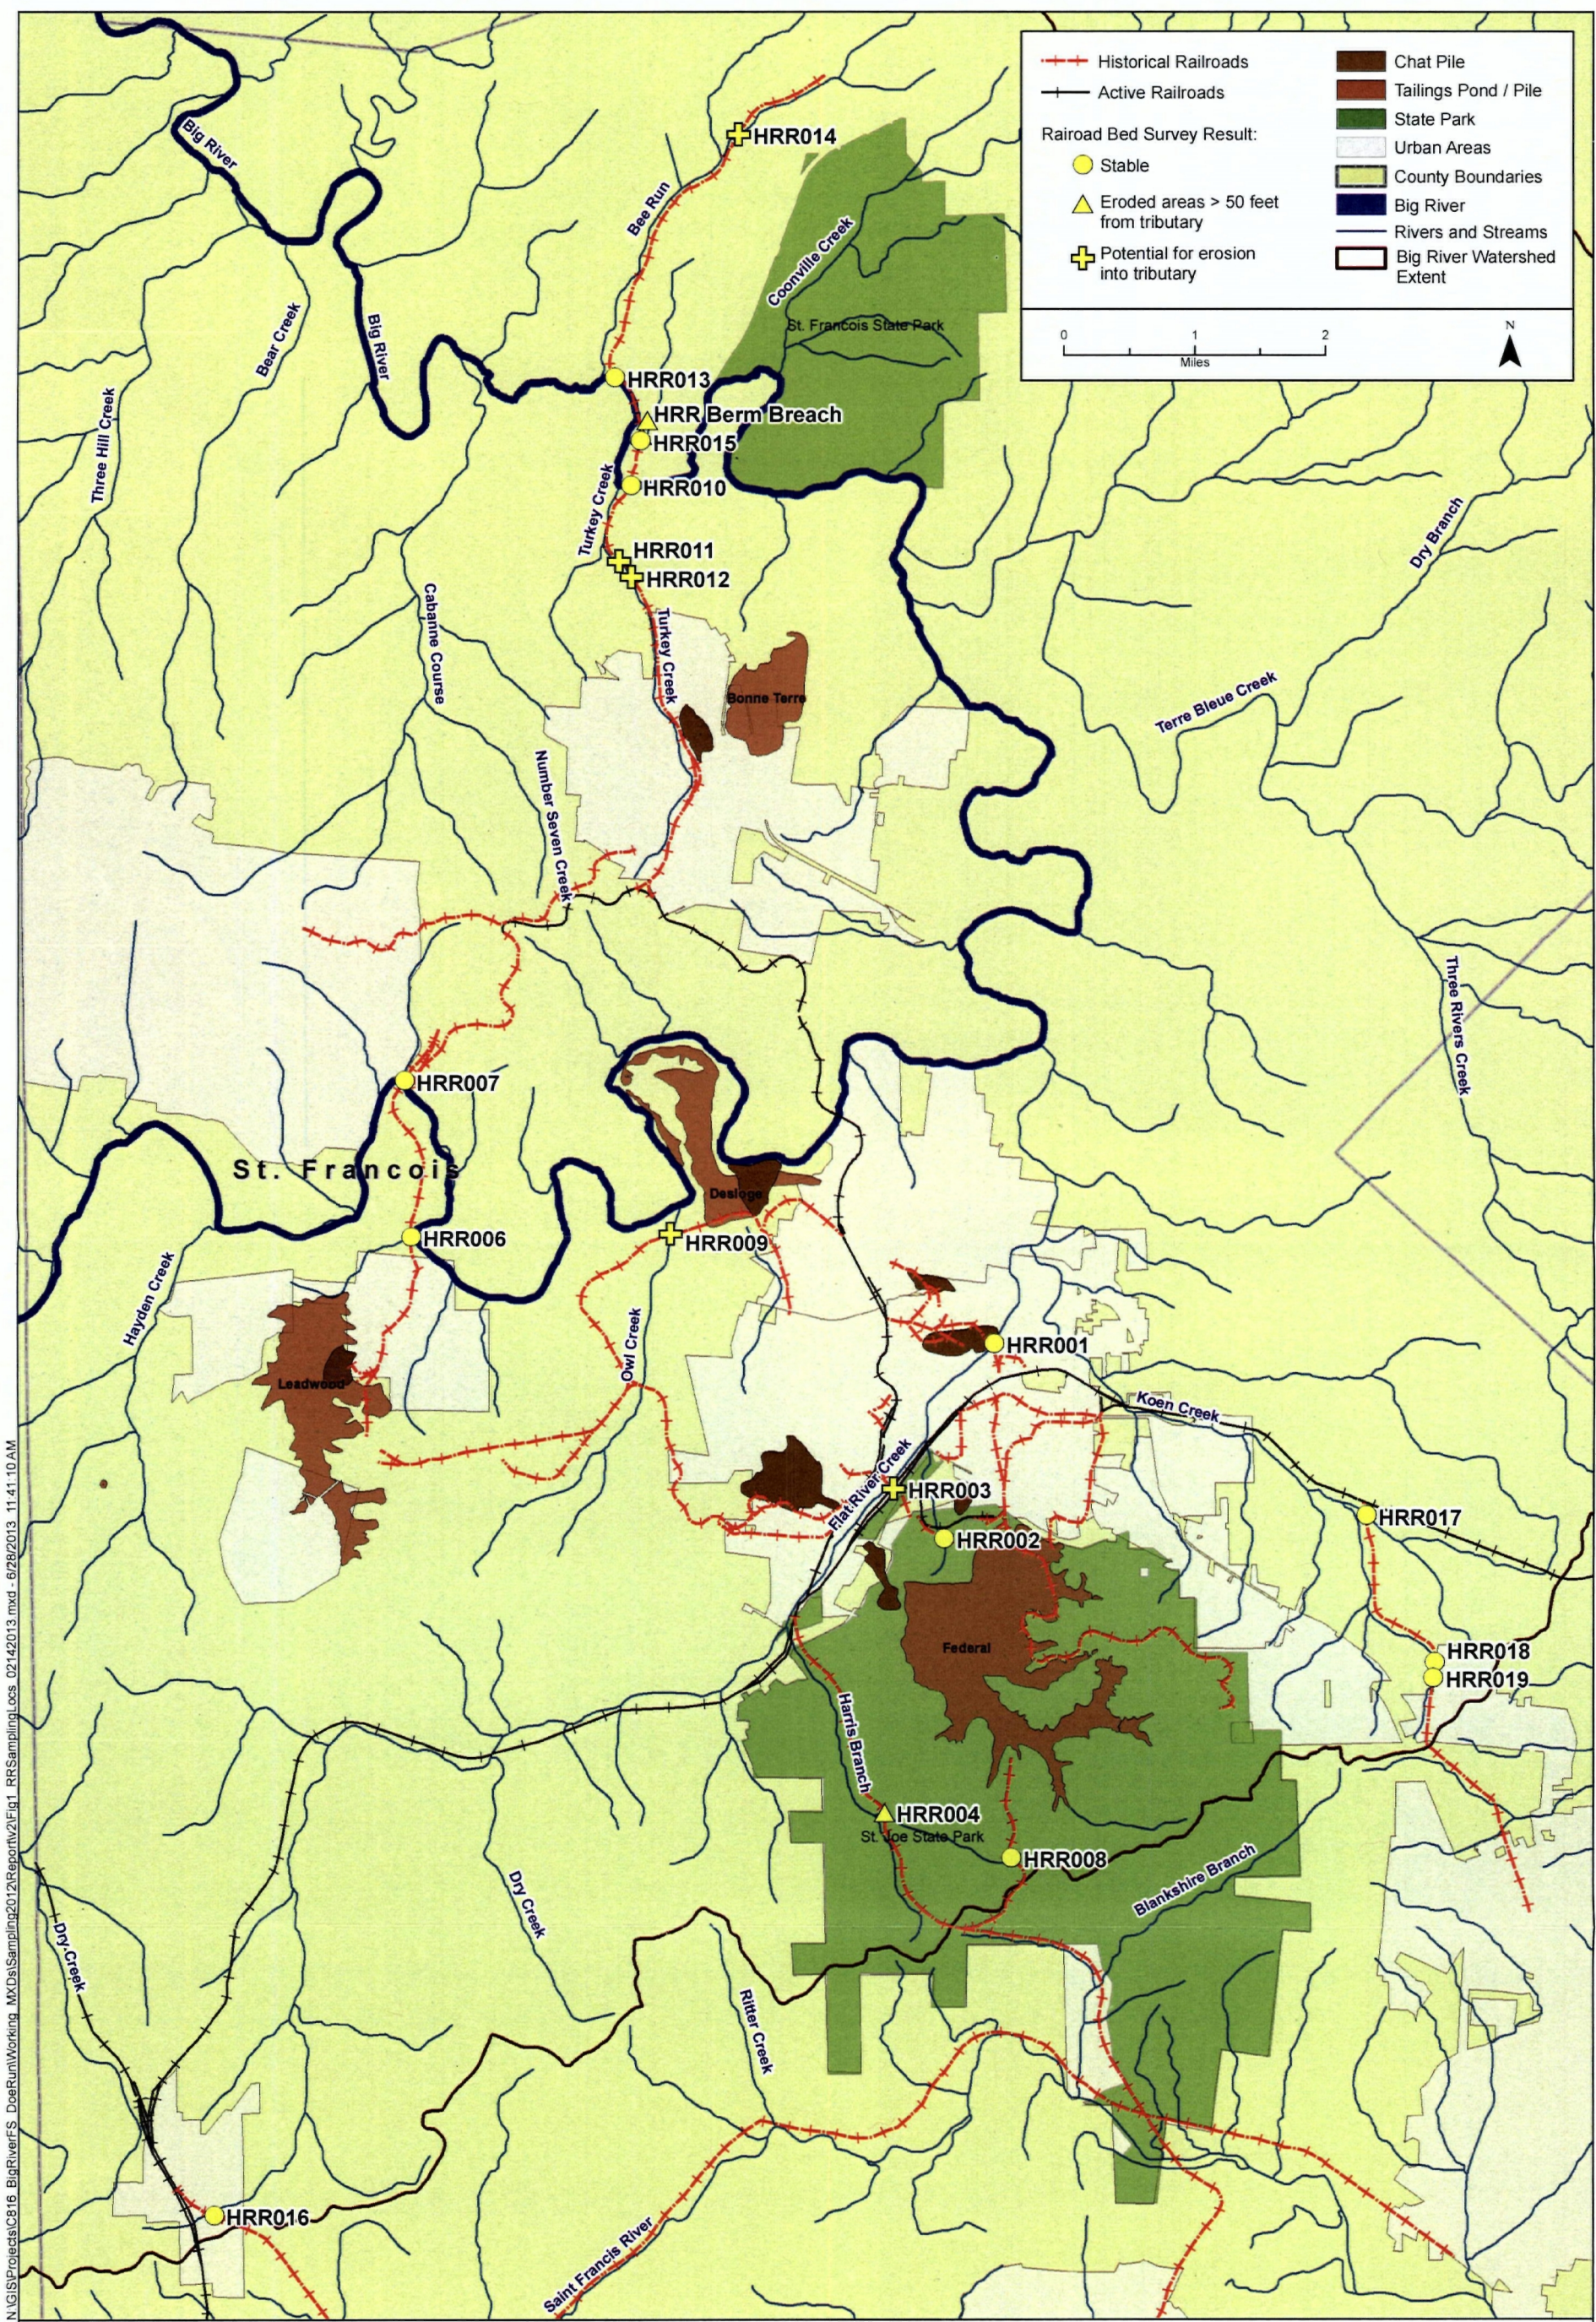
**Figure 1.**  
Visual Railroad Bed Survey Results  
River and Non-Residential Areas (OU-2)  
St. Francois County Mining Area, Missouri

The visual railroad bed survey was performed at 19 locations along Big River and tributaries within St. Francois County where the railroad beds were identified as being within approximately 50 ft of Big River or a tributary (Figure 1, Table 1). To identify potential survey locations, railroad beds (NewFields 2006) and waterbodies were mapped in geographic information systems (GIS). A 50-ft buffer was delineated around the railroad beds and locations where the railroad buffer overlapped with a waterbody were identified for the survey. The approach was to survey areas within 50 ft of the waterways, however, several surveyed areas identified initially were actually farther than 50 ft. The historical railroad GIS shapefile is low in resolution and presents some uncertainty as to the distance from the railroad to a waterbody; this resulted in some of the surveyed areas being farther than the target distance from the waterbody. Over the course of the field activity, an additional area of historical railroad bed erosion was observed and assigned the sample name "HRR Berm Breach."

The remains of a former railroad trestle cross Flat River Creek at approximately river mile 5.3 (upstream of the confluence with Big River). A visual inspection of the trestle supports and the associated historic railroad bed was performed at survey location HRR003 (Figure 1). Erosion of the railroad bed along the eastern riverbank was observed; at the time of the survey eroded railroad bed material was not observed in Flat River Creek. An estimated 190 ft<sup>3</sup> of railroad bed material have eroded and this location may be an ongoing source of mining related material to Flat River Creek (Table 3).

Owl Creek passes beneath the abandoned Mississippi River and Bonne Terre (MR and BT) Railroad through a cement box culvert. The railroad crossing and Owl Creek culvert were investigated as part of this visual survey (Station ID HRR009; Figure 1). An erosional area of the railroad bed was observed on the bank to the northwest of the culvert. Exposed mining-related material was observed on the northeastern slope of the culvert but did not appear to be eroding into the creek. Erosion of the railroad crossing was not observed upstream of the box culvert.

An abandoned railroad bed runs parallel to Turkey Creek from the Bonne Terre piles to the Big River confluence, a distance of approximately 3 miles (Figure 1). A section of railroad nearest the western Bonne Terre pile was surveyed in 2007; the top portion of the bed was characterized as chat (NewFields 2007a). Minor erosion of the railroad bed nearest Bonne Terre was noted during the 2007 sediment probing survey; however, sediment probing was not performed in Turkey Creek at that time because the volume appeared to be too small to measure (NewFields 2007b).

Exposed and erosional areas were observed at survey location HRR014, the site of an abandoned railroad bridge that crosses the tributary Bee Run (Figure 1). Off road vehicle
